# **EVALUATION OF THE STRUCTURAL INTEGRITY OF AN AIRCRAFT LOADING WALKWAY UNDER SEVERE FUEL-SPILL FIRE CONDITIONS**

**FINAL REPORT**

1. Report No. FAA-RD-73-144		2. Government Accession No.		3. Recipient's Catalog No.	
4. Title and Subtitle EVALUATION OF THE STRUCTURAL INTEGRITY OF AN AIRCRAFT LOADING WALKWAY UNDER SEVERE FUEL-SPILL FIRE CONDITIONS				5. Report Date October 1973

6. Performing Organization Code	
7. Author(s) George B. Geyer, Lawrence M. Neri, Charles H. Urban				8. Performing Organization Report No. FAA-NA-73-79

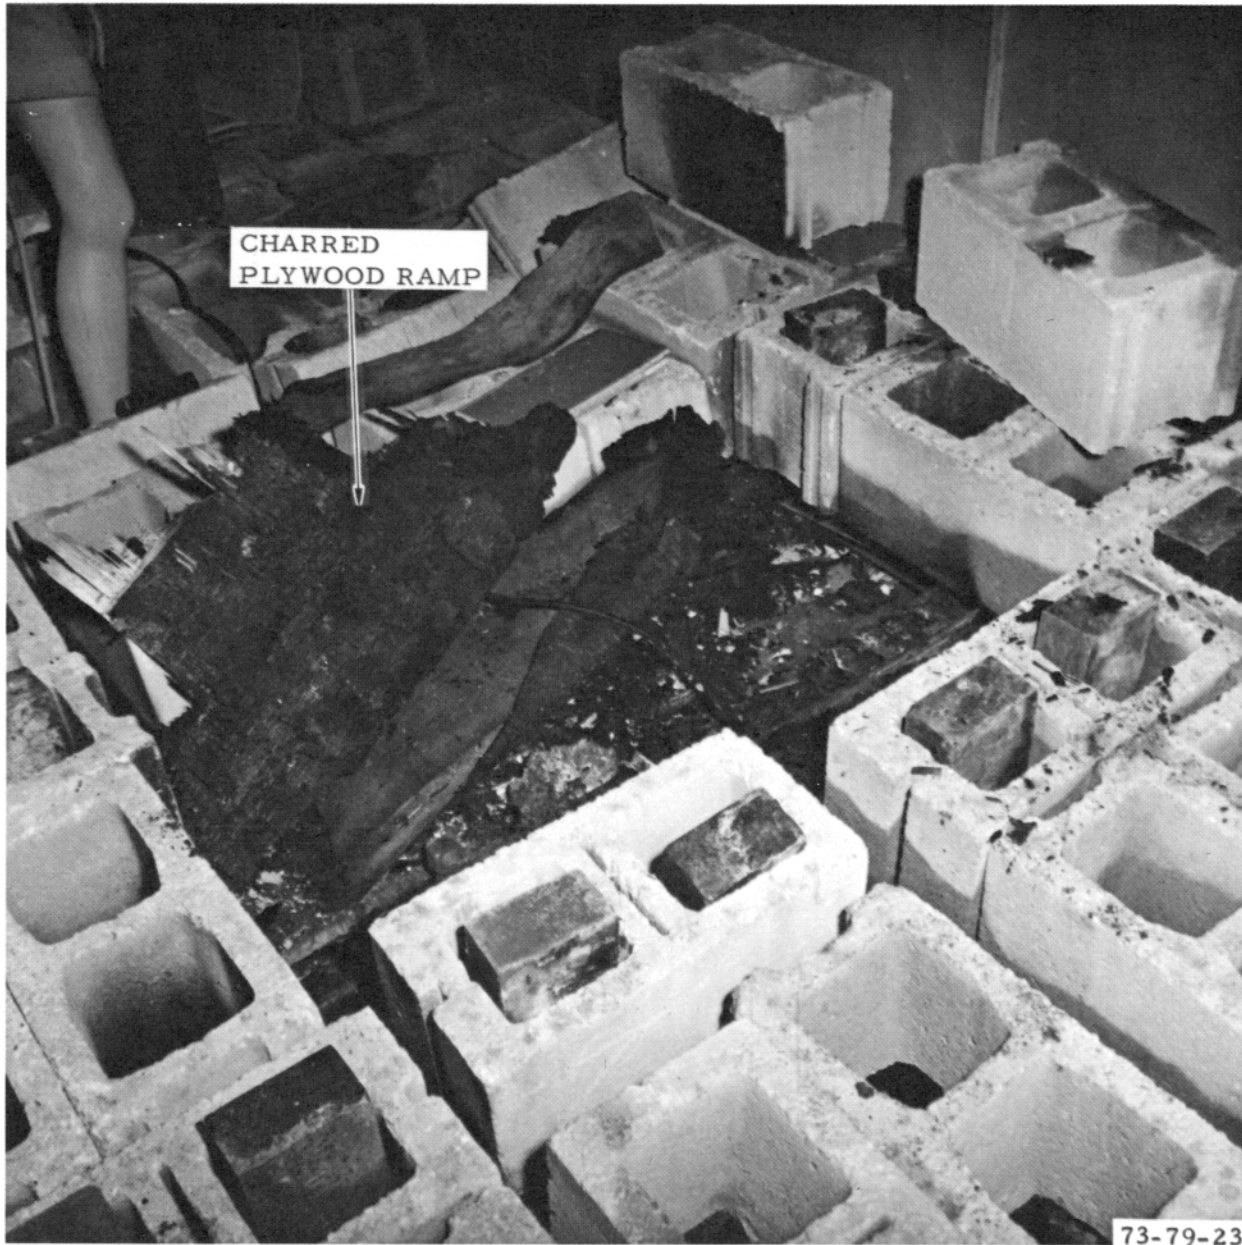
FIGURE 23. EFFECTS OF FIRE IN THE FLOOR RAMP SECTION BETWEEN TUNNELS B AND C

FLOOR RAMP FIRE. After the external fuel fire had been extinguished, it was observed that the overlapping floor section between Tunnels B and C was on fire. To obtain access to this area, it was necessary to remove some of the Waylite blocks and chop out a section of the flooring. Upon investigation it was evident that the seat of the fire was in the sloping wooden ramp between the walkway sections. The cut-away floor ramp section is shown in Figure 23. There was strong evidence indicating that the cause of this fire was by flame penetration beneath the ramp resulting from the complete thermal disintegration of the weather stripping between the two floor sections. The extent of damage to the weather stripping between Tunnels B and C is indicated in Figure 24.

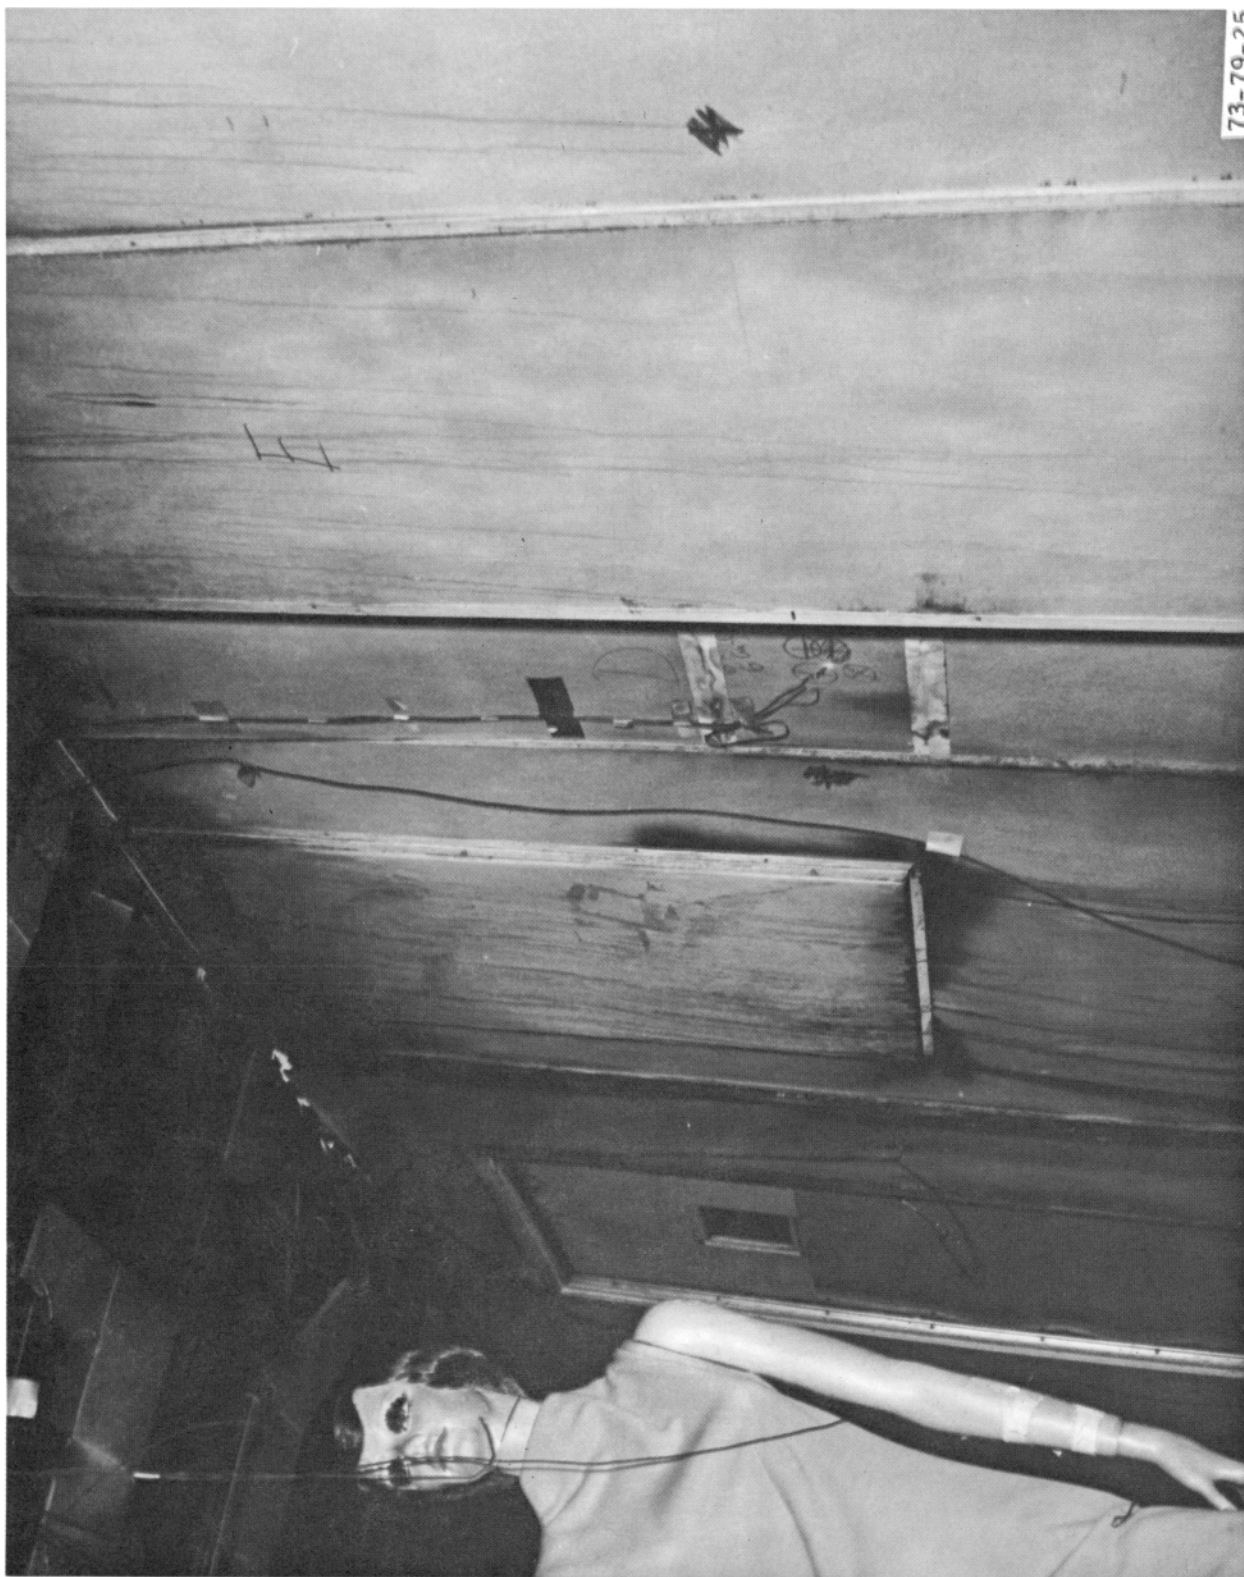
FIGURE 25. CEILING AND WALL FIRE DAMAGE IN TUNNEL C

FIRE DAMAGE TO THE WALLS AND CEILING. As a consequence of the thermal disintegration of the weather stripping and the pyrolysis of the plywood flooring, smoke and hot gases penetrated the space between the corrugations in the sidewalls and above the ceiling tiles of the walkway causing the damage indicated in Figure 25. This photograph shows a buckled asbestos-cement wall panel and the condition of the mineral acoustical ceiling tiles in the section of the walkway (Tunnel C) adjacent to the fuselage section after the test. The condition of these ceiling tiles is representative of only a relatively small portion of the ceiling adjacent to the fuselage. Furthermore, this

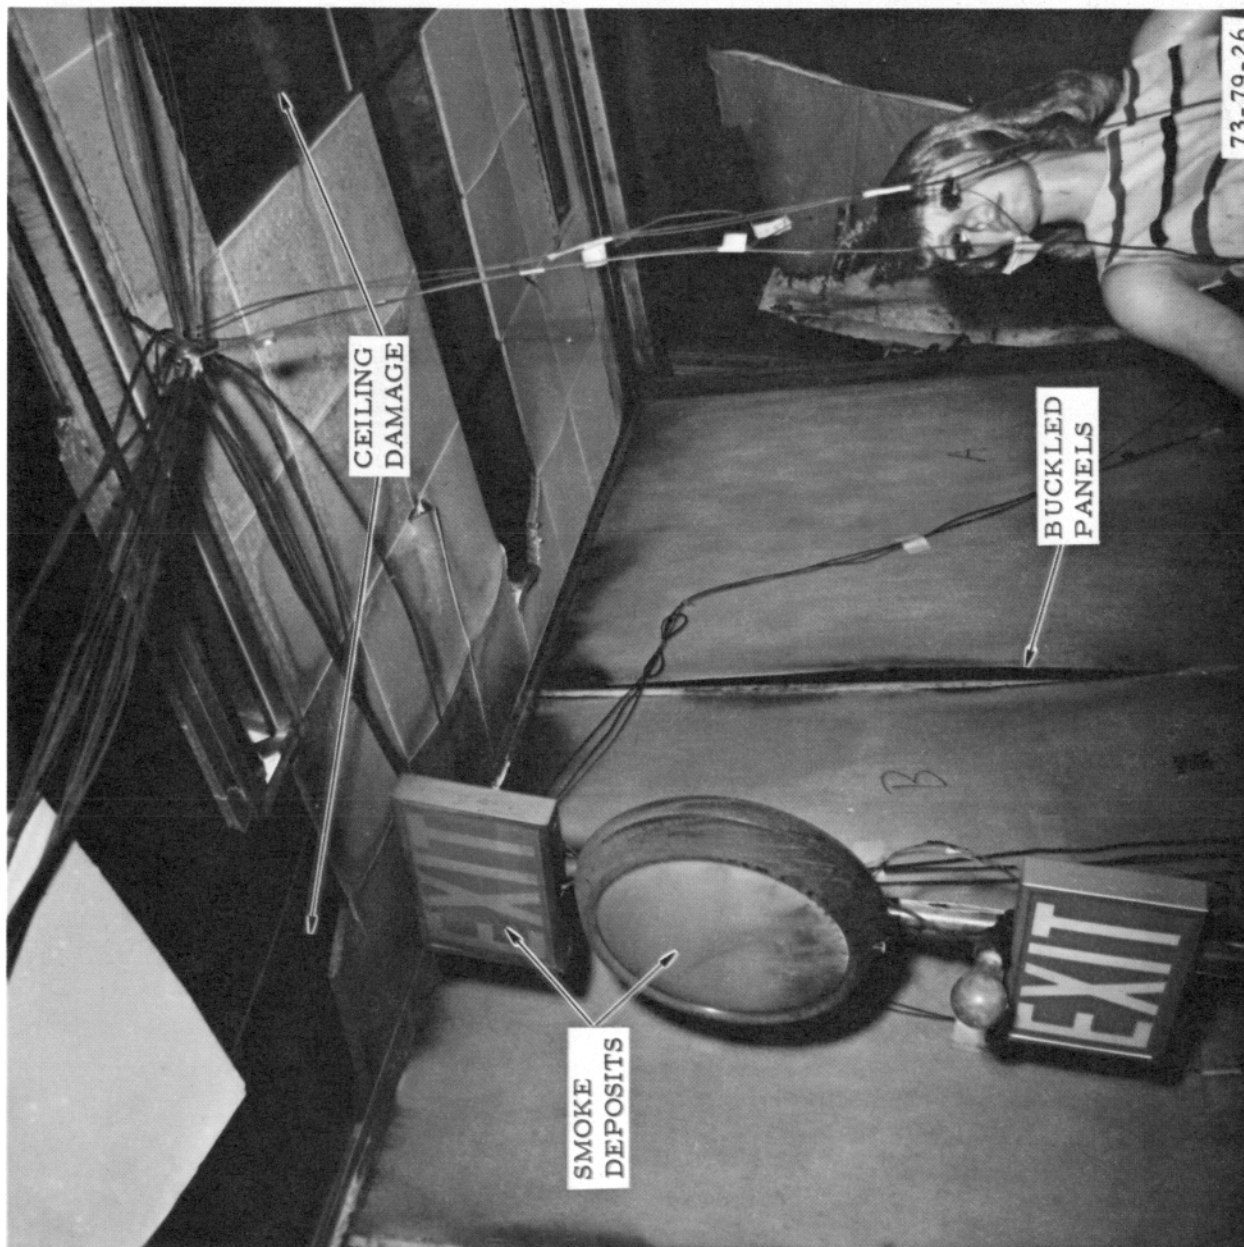
FIGURE 26. "EXIT" SIGN ARRAY SHOWING EVIDENCE OF SMOKE PENETRATION AND DISCOLORATION

section of the walkway had been damaged in transit to NAFEC and the tiles were reset on the existing structure. In Figure 26 the wall and ceiling tiles, and the uppermost "EXIT" sign and clock show evidence of smoke penetration and discoloration. However, in this regard it is also of interest to note that the dress on the manikin in Figure 27, which was approximately 15 feet from the fuselage section, shows no appreciable deposit of smoke or soot.

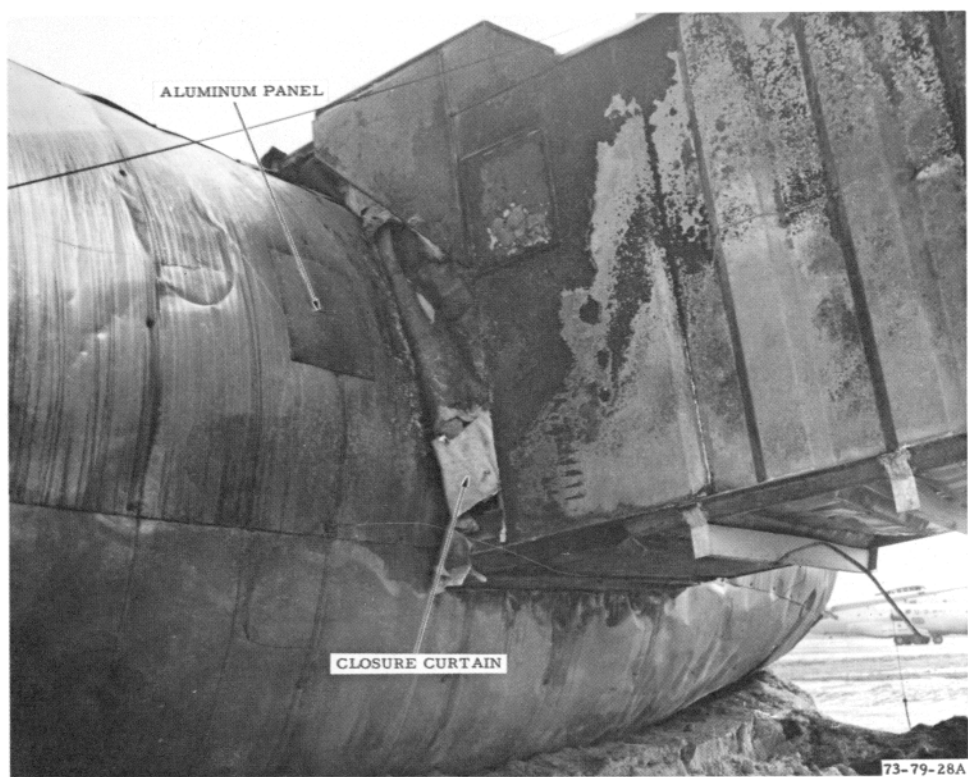
A. ALUMINUM PANEL EXPOSED ON THE UPWIND SIDE OF THE WALKWAY

FIGURE 28. THE EFFECTS OF FLAME IMPINGEMENT ON THE ALUMINUM PANELS

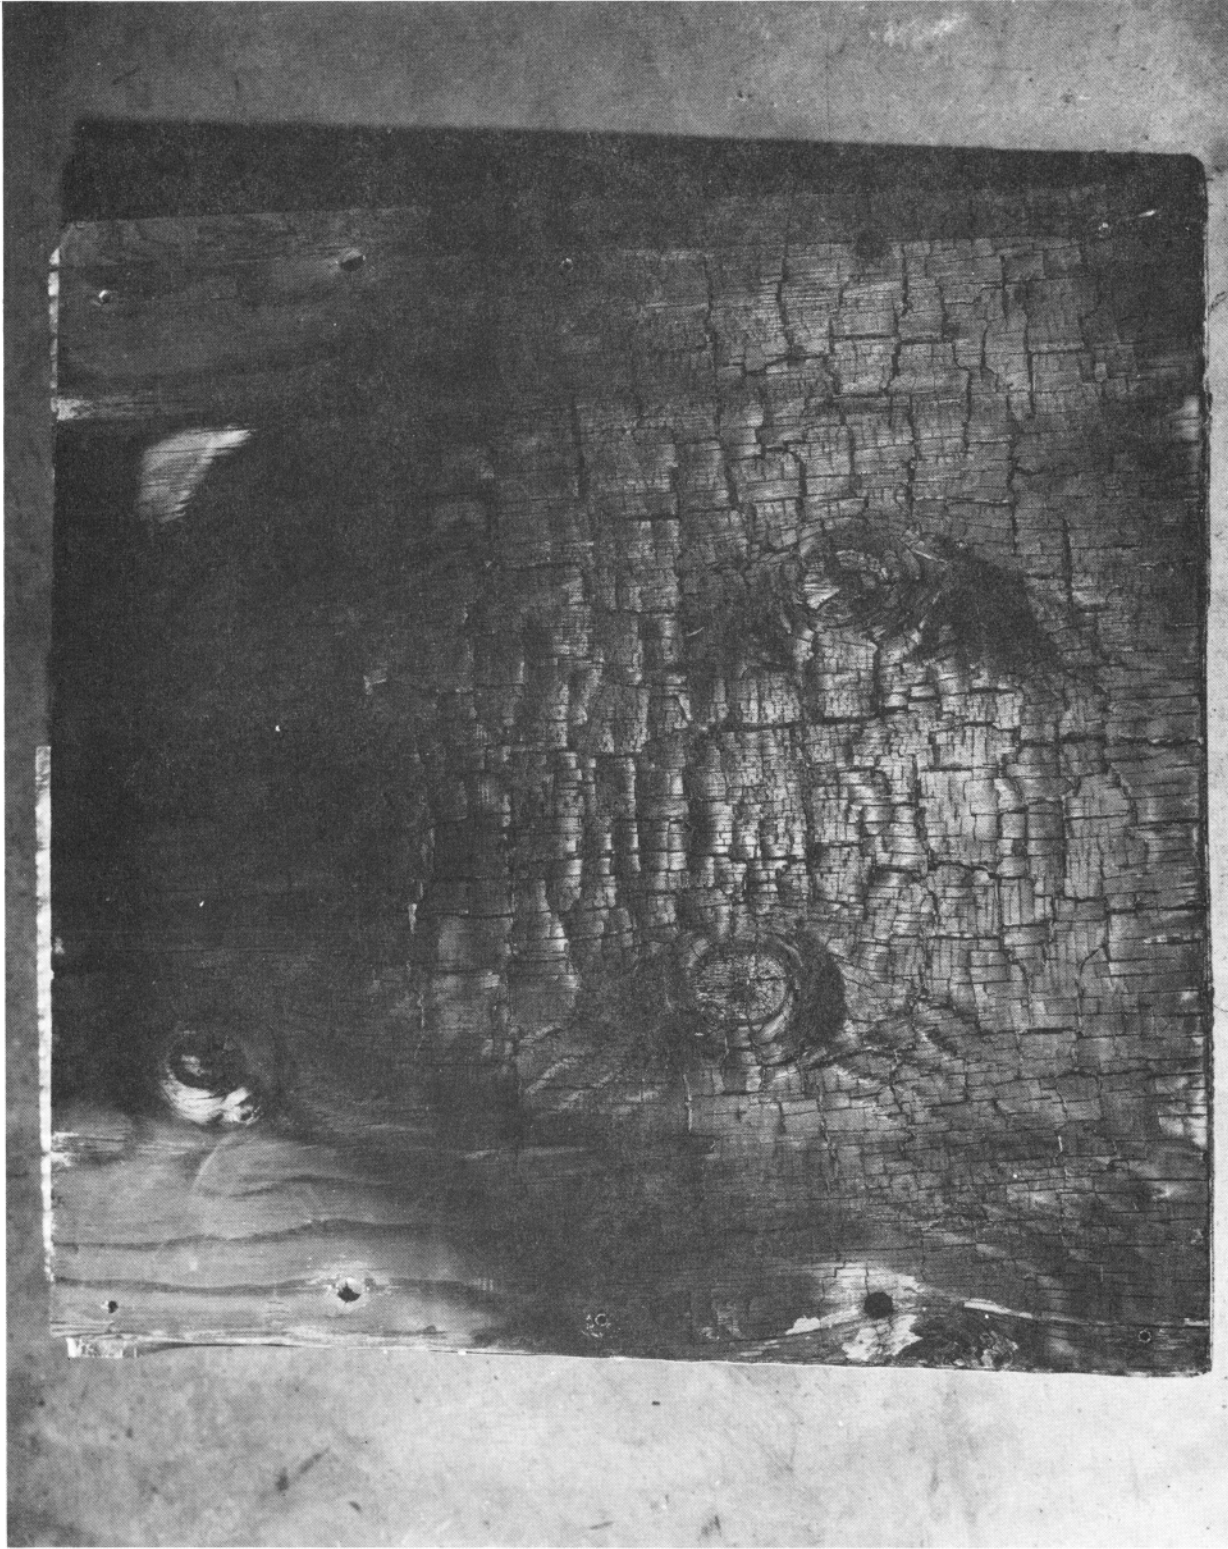
FIGURE 33. CHARRING OF THE PLYWOOD FLOORING SEPARATED FROM THE CORRUGATED METAL BY AN AIRSPACE

Test No. 2 - Floor Panel Sections. The construction of the floor test panels was the same as that employed in the aircraft loading walkway. However, as a consequence of the corrugations in the steel, two different test configurations are possible. The most severe condition is shown schematically in Figure 31 in which the plywood flooring is bearing directly on the metal corrugation in the area of burner flame impingement, while the least severe condition is shown in Figure 32 where there is a 3 3/16-inch deep airspace between the metal and plywood flooring within the area of flame impingement.

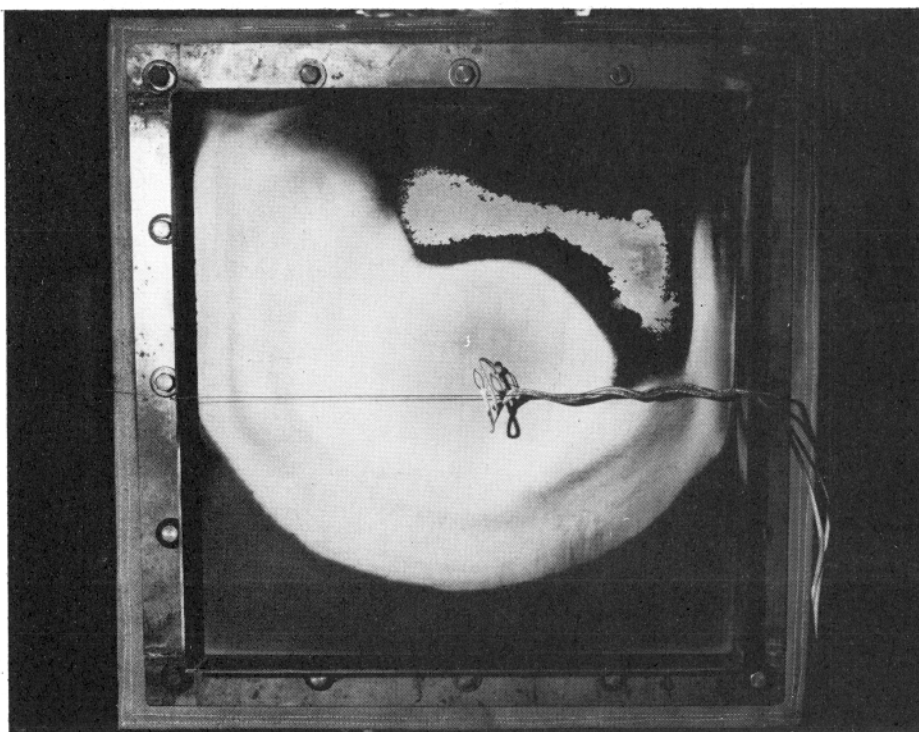
a. Exterior View After 10 Minutes Flame Exposure.

The effects of the burner flame impingement on the canopy material are indicated by the profiles in Figure 35 where temperature rise is plotted as a function of fire exposure time. From these data it is evident that the air temperature within the smoke chamber remained relatively low, reaching 110°F after 5 minutes and a maximum of only 130°F at the end of the 10-minute fire exposure period.

FIGURE 36. DAMAGE TO THE WALKWAY CLOSURE CANOPY CAUSED BY FIRE EXPOSURE

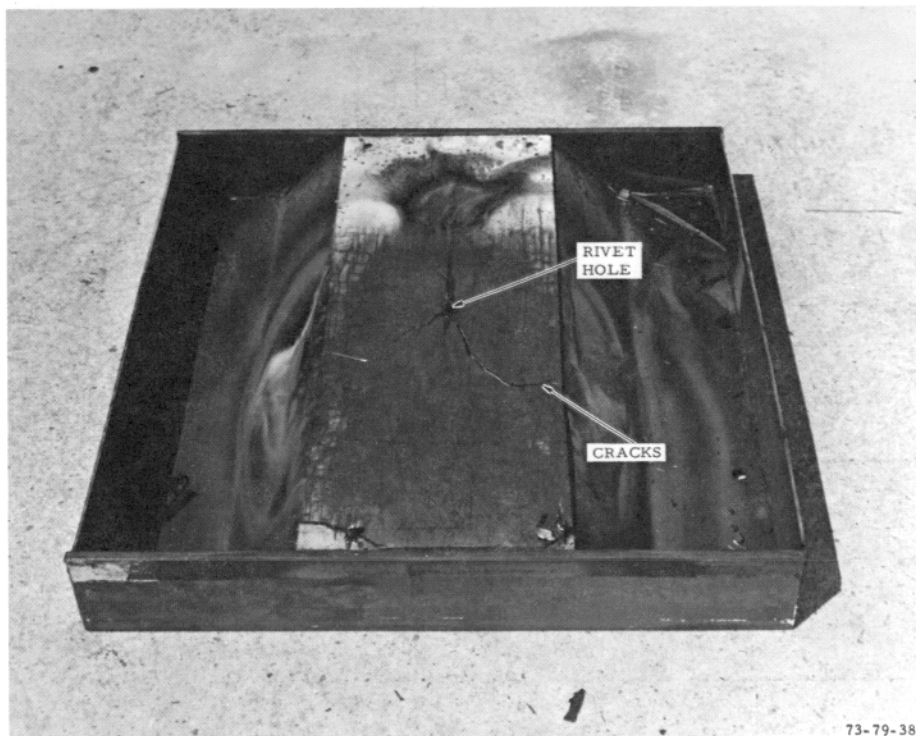
73-79-38A

A. THERMAL CRACK IN THE ASBESTOS-CEMENT BOARD

FIGURE 38. TYPICAL THERMAL AND STRUCTURAL DAMAGE TO THE ASBESTOS-CEMENT BOARD MODIFIED FLOOR PANELS

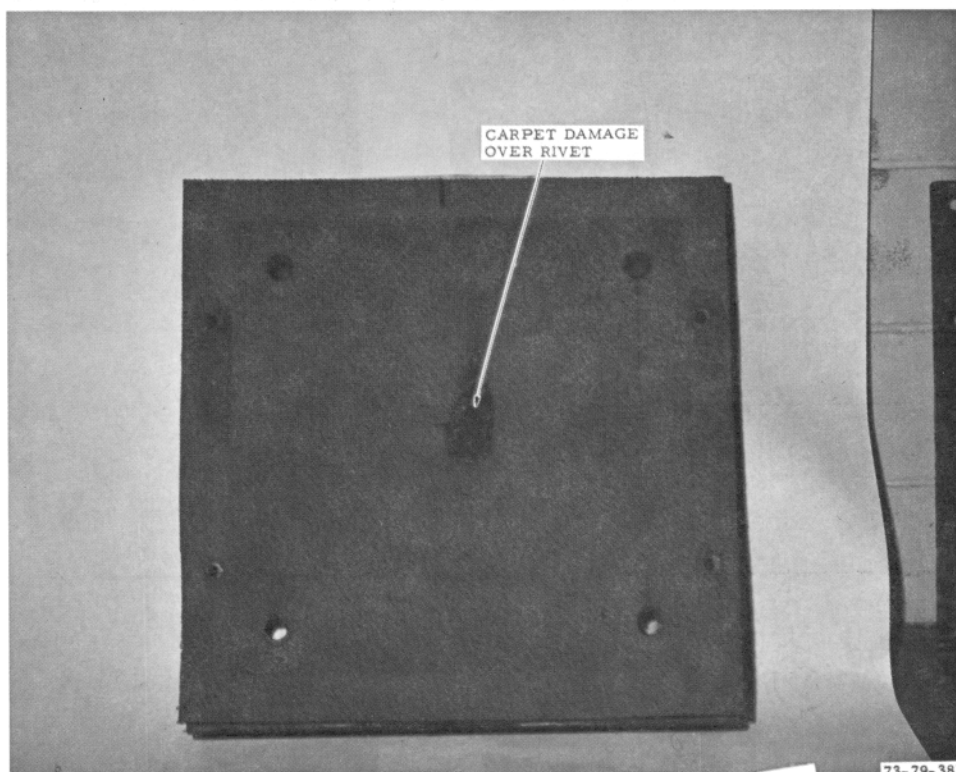
73-79-38B

During the course of the first experiment employing a composite panel, it was evident that when the plywood flooring was riveted to the corrugated steel in the configuration shown in Figure 38A the rivet in the

B. RUG DAMAGE AT POINT OF RIVET CONTACT
